Accu-Lube®

Frequency Generator Bladder Repair Kit, Part # 9046

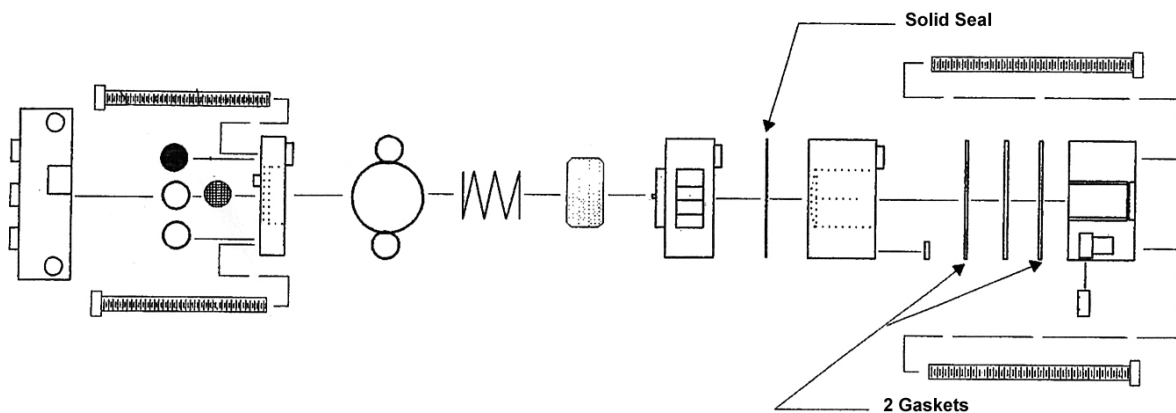
Dirty or oily compressed air can damage the frequency generator. If your applicator no longer pumps or pumps extremely fast the problem can usually be fixed by replacing the bladders included in the repair kit into your frequency generator. To prevent the problem from re-occurring it is recommended that you add a coalescing filter to remove oil from the air supply and a particle filter to remove dirt.

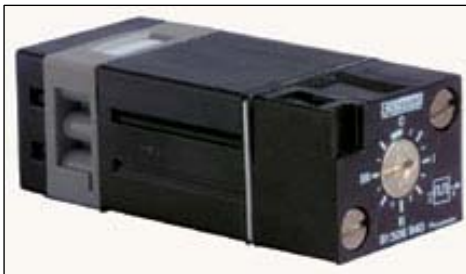
9460 Frequency Generator (no base plate)

Connect the main air supply to the middle port (2) on the back of the base plate of the frequency generator. Connect the cycled air from port (3) of the base plate to the pump(s).
